Finished Water

A PHOTOGRAPHIC PROFILE

LAKE STILLHOUSE WATER PLANT PROVIDES ADDITIONAL WATER SOURCE FOR 300,000 TEXAS RESIDENTS

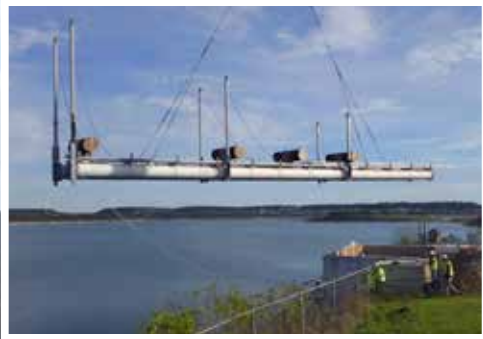
A slanted tube intake assembly (inset) was installed at Stillhouse Hollow Lake, providing a new supply source for Bell County, Texas, residents with the completion of the new Lake Stillhouse Water Treatment Plant.

Physical Size: The plant includes two sedimentation trains and four conventional dual media filters. The project also includes a dual slant tube intake and about 3,500 feet of 36-inch raw water line.

Special Features: The plant's slanted tube intake assembly and installation required a dive team, inflatable ballasts, and tremendous coordination between land and water crews.
